10 Troubleshooting

Overview

A block functional diagram of a typical TVRO satellite receiving station is shown in Figure 10.1.

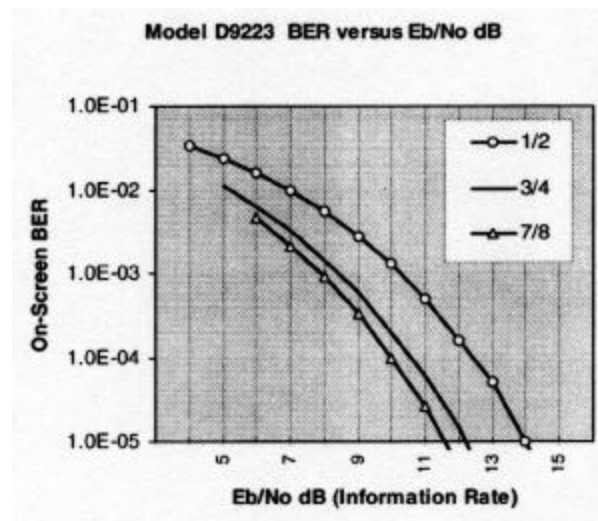
Figure 10.6, BER vs. Information Rate (typical)

The Bit Error Rate (BER) associated with the received digital signal is extremely important, as it indicates how much of the received signal information contains errors caused by electrical noise/interference that must be corrected. The BER is displayed in scientific notation. For example, a received signal BER of 1E-5 (or 1.0×10^{-5}) is less than a signal BER of 2E-3 (or 2.0×10^{-3}). Figure 10.6 shows typical signal quality (BER) values obtained for various FEC rates as displayed on-screen at the Installer menu.

The E_b/N_0 (Information Rate) is normalized as the energy-per-bit for a 1 Hz noise bandwidth, and applies to any data rate. The Information Rate is the useful data rate following Forward Error Correction (FEC), as defined by the DVB standard. The threshold for E_b/N_0 depends on the Viterbi FEC rate associated with the uplink signal. Table 10.4 lists the threshold E_b/N_0 for each of the available FEC rates.

For example, if the receiver is operating at 3/4 FEC, look at the middle curve in Figure 10.6. If the displayed BER is near $1E-2$, this corresponds to a E_b/N_0 of 5.5 dB (threshold). Below this threshold the video display is likely to break up, or signal synchronization can be lost. If the displayed BER is $1E-4$, the receiver is operating at a E_b/N_0 of 10.5 dB, which is approximately 5 dB over the threshold. If the received downlink signal is Ku (that is, clear sky conditions), the displayed BER may be approximately $1E-4$. With heavy precipitation, the BER is likely to increase to $1E-2$, corresponding to a loss of 5 dB. The 1/2 FEC rate threshold corresponds to a BER of $3E-2$, and the 7/8 FEC threshold to a BER of $3E-3$.

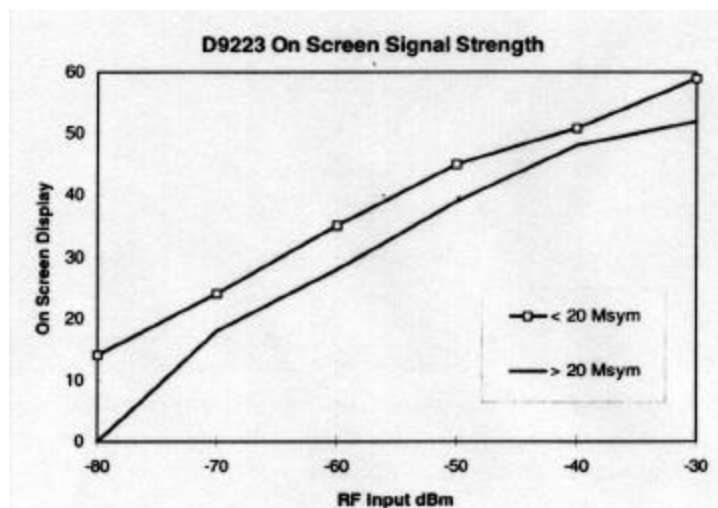
Figure 10.7, Signal Level vs. RF Signal Input

Figure 10.7 shows typical Signal Level values obtained for Symbol Rates above and below 20 <Symbols/s, as displayed on-screen at the Installer menu.

Displayed Signal Level values appear slightly higher for Symbol Rates below 20 MS/s than for Symbol Rates above 20 MS/s.
